Briggs, KM, Loveridge, FA & Glendinning, S 2017, 'Failures in transport infrastructure embankments', *Engineering Geology*, vol. 219, pp. 107-117. <https://doi.org/10.1016/j.enggeo.2016.07.016>

## **Failures in transport infrastructure embankments**

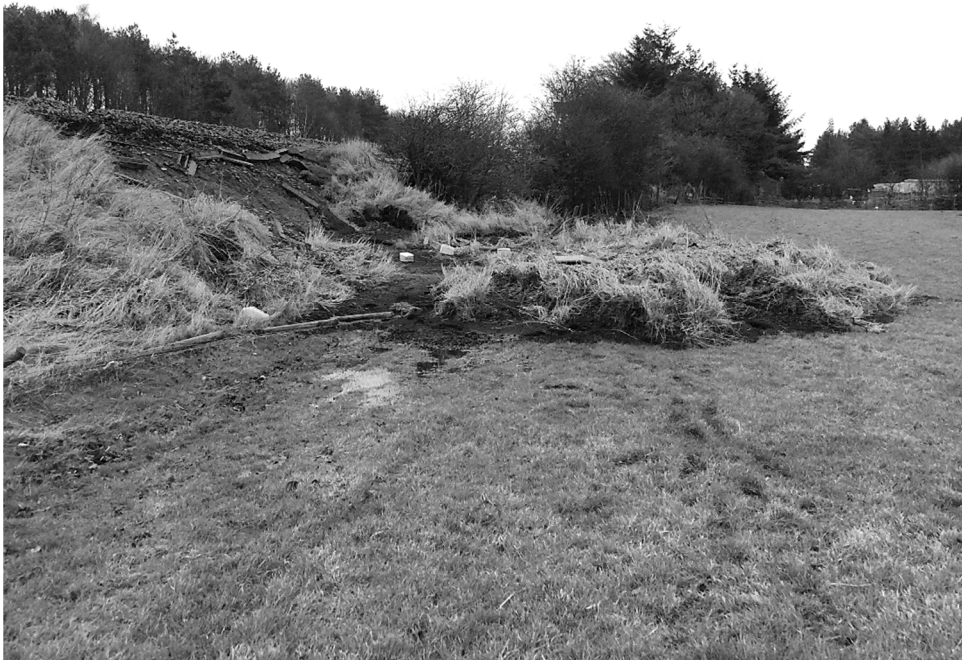
**Figure 5b: Shallow failure of a railway embankment slope at Willow Gap on the Newcastle to Carlisle railway line (photo courtesy of David Hutchinson, Network Rail)**

with the final rupture triggered by an increase in pore water pressure). The first of these failure mechanisms occurs in both highway and railway embankment slopes, often as shallow slope failures (Figure 5b) but sometimes as deeper seated failures. The second and last of these failure mechanisms are associated with excessive deformation and deep-seated failure surfaces in railway embankments, but much less so in highway embankments (Table 2).

Railway embankments are susceptible to rainfall-induced pore water pressure increase and the shear failure of the embankment slope (Figure 5b). For this reason, slope drainage has long been recognised as an important slope remediation measure (Birch & Dewar, 2002). Loveridge *et al.*, (2010) showed that five times as many major railway delay incidents (>8h duration) due to geotechnical causes occurred in the winter months (242 incidents) than in the summer months (44 incidents) across all Network Rail territories between 2000 and 2003. The delays were attributed to the ultimate failure of earthworks driven by elevated pore water pressures or washout. Ultimate limit state failures in Networks Rail's South East Territory (SET) were also correlated with monthly winter rainfall in excess of the 1971-2000 long-term average (LTA). Maximum monthly rainfall close to 200% of the LTA in the winters of 2000-2001, 2001-2002 and 2006-2007 correlated with more than thirty, ten and a further ten failures in the region respectively. Supporting hydrological modelling by Loveridge *et al.*, (2010) showed that the increased permeability of railway embankments (often greater than  $5 \times 10^{-8} \text{ ms}^{-1}$ ) relative to highway embankments (often less than  $1 \times 10^{-8} \text{ ms}^{-1}$ ) made railway embankments more susceptible to rainfall infiltration, the development of significant wetting fronts and raised pore water pressure during wet winter weather. Surface run-off was more likely in highway embankments, which are of lower permeability (except at the very near surface).
